# Manhole Inspection Summary

Manhole # S41WW\_011MH

**Location** Address: **3220 LOCH RAVEN BLVD**

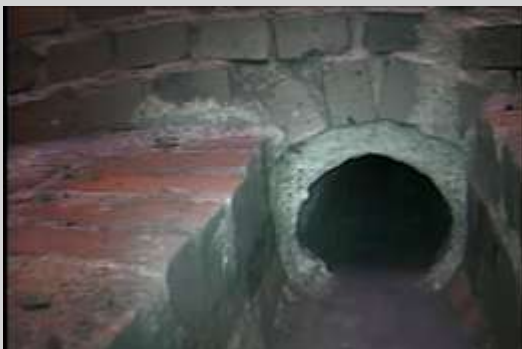
### 10 in. Circular Gravity Sewer Pipe In @ 4 O'Clock

Rod and Bar (Angled)

Pipe Material: **Clay** ☐ Pipe Lined

Infiltration: **None** Pipe Seal Cond: **Unknown**
